**Test 1
Non Cyclonic Testing
of
0.42mm BMT
KlipLok Classic 700 (Lysaght)
Roof Sheeting
with
75mm Spacer and 100mm
Insulation**

**PREPARED FOR
Carey Roofing Products Pty Ltd**

No. OF PAGES: 15
DISTRIBUTION: CLIENT (1)
SCHOOL (1)
REFERENCE NUMBER: C130501-1
DATE OF ISSUE: 8 August 2013

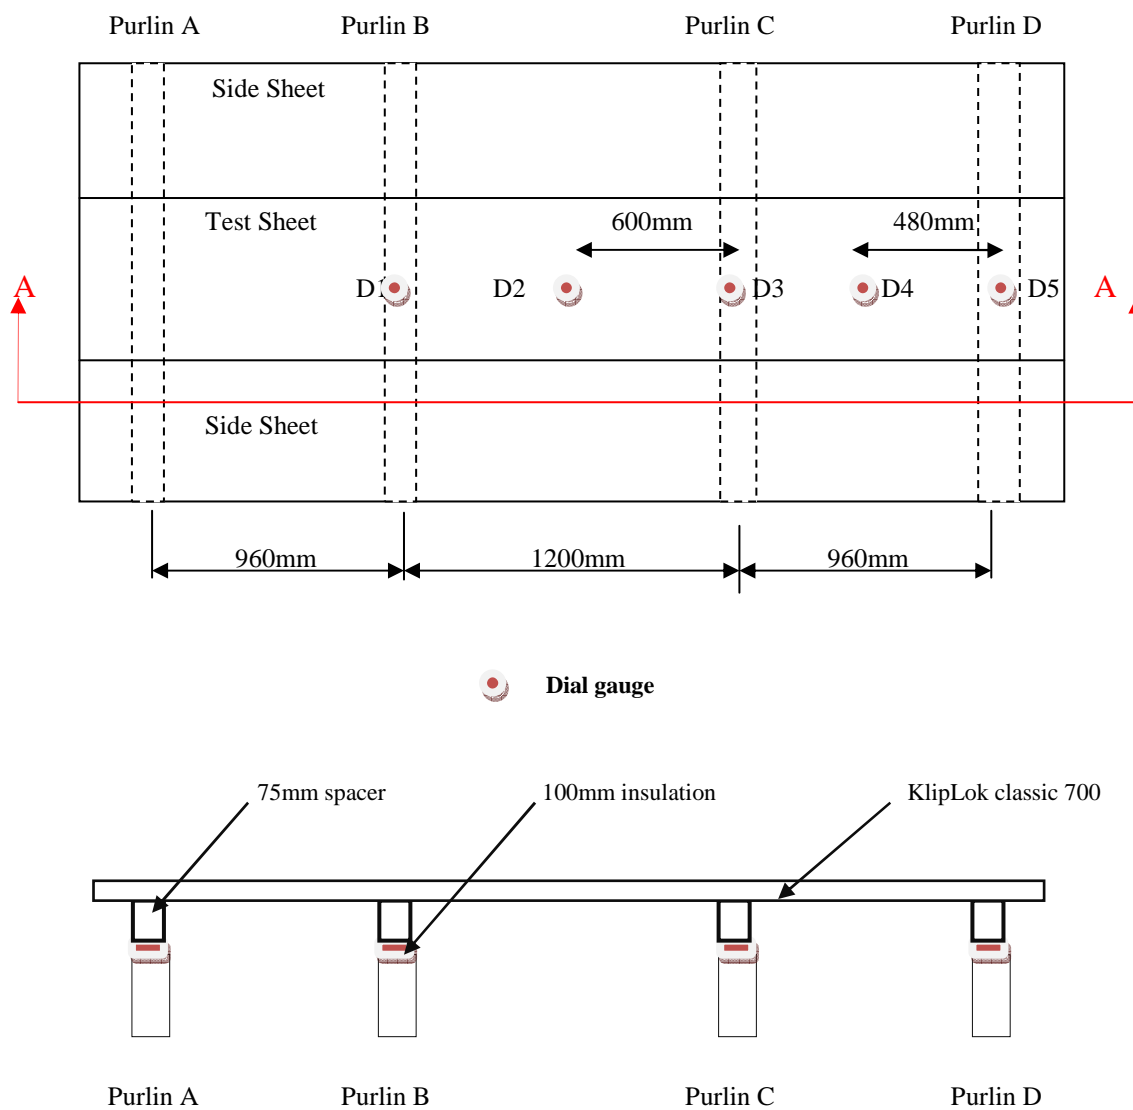
Figure 1. Test setup.

Figures 1 to 3 show the test setup and installation arrangement of the panels on the test rig prior to testing. The side sheets and purlin connections to the loading frame were considered to be the part of the test rig, and hence were not under test. The setup of the air bag rig and the set up of the test specimens were undertaken by EngTest. Table 1 provides a summary of the test details and configurations.

Section A-A

For serviceability limit state testing, deflections were measured for each load increment using dial gauges placed at the locations requested by Rachael Zeuner as shown in Figures 1 and 3. The target pressure for serviceability was also provided by Rachael Zeuner. Table 2 shows summary of dial gauges readings during serviceability limit state testing for each load increment, and Table 3 shows the deflections measured at the dial gages locations during the testing for each load increment. The results of the serviceability load test are presented in Figure 4.

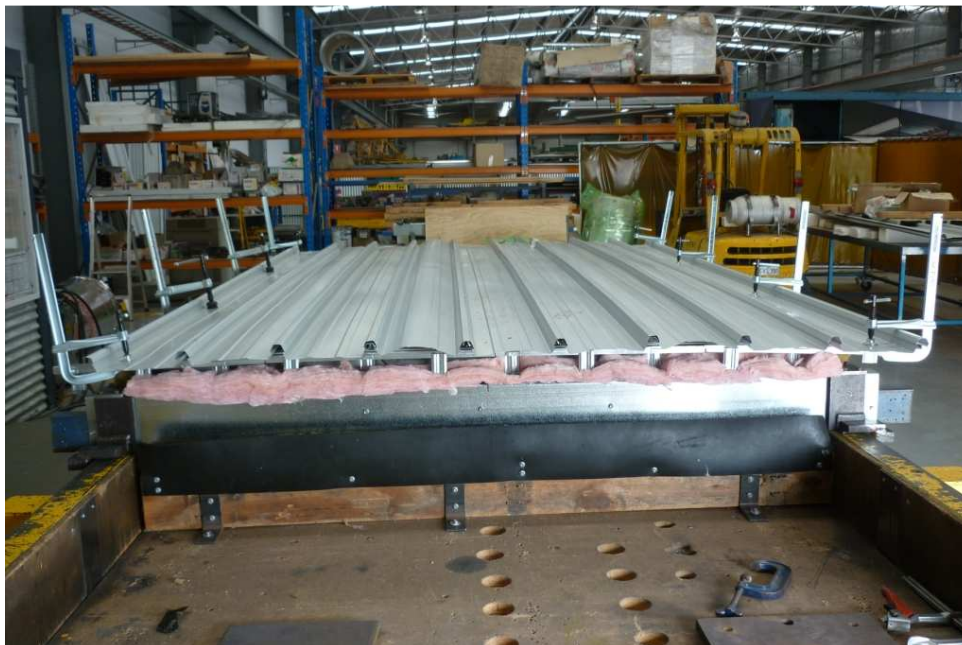
Figure 5. Deflection of the sheet at airbag pressure of 7.68kPa.

Airbag Pressure (kPa)	Comments
2.88	Pressure was maintained for a period of one minute. Increasing deflection.
3.38-7.68	Pressure was maintained for a period of one minute. Increasing deflection (Figure 5).
7.89	Panel failed . Centre sheet pulled out from the clips. Separation of centre test panel from side panels at overlaps (Figures 6-7). Failure occurred at 7.89kPa .

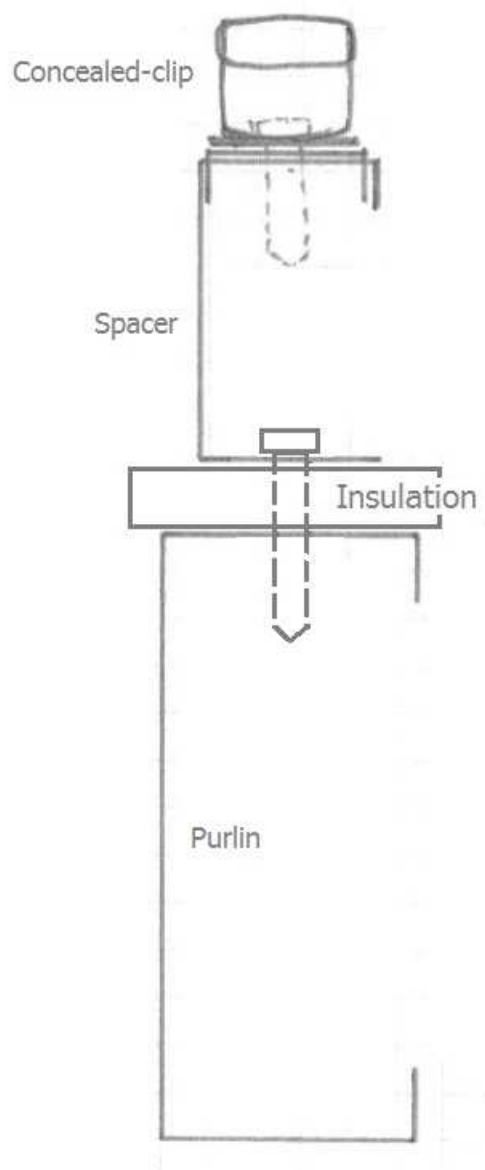
Spacer Installation Diagram

- Using a socket drive (S116 socket)
- Place screw into a S116 socket drive.
- Put the socket drive through the hole on the top plate of the spacer to fix the legs of the spacer onto the steel purlin supports.

- Fix concealed clip to spacer
